FINAL REPORT MARCH 2001

REPORT NO. 00-02

S-280 Shelter Tie-down Kit TP-94-01, Transportability Testing Procedures

S-280 SHELTER TIE-DOWN KIT TP-94-01, Transportability Testing Procedures

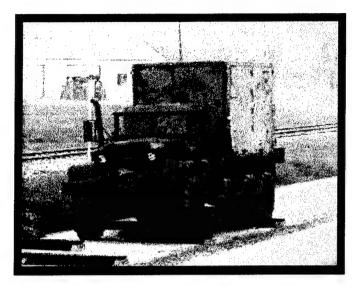
Hazard course test of S-280 Shelter with Tie-down Kit

Remarks: The tie-down anchor on the front passenger side came out during transport over the road course. The vibration of the shelter rings against the tie-down anchors caused the chain anchors to disengage. The overall shelter movement was 0.5 inches toward the passenger side of the vehicle. The remaining three tie-downs did not disengage during testing. The tie-down was reattached and testing continued.

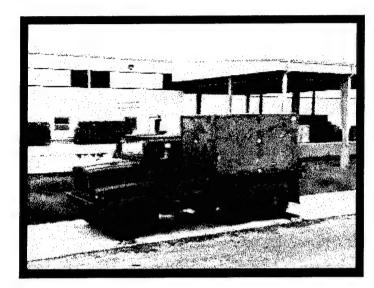
Hazard course testing of S-280 Shelter with Tie-down Kit

Remarks: No damage or failures occurred with the S-280 Shelter, S-280 Shelter Tie-down Kit or the vehicle.

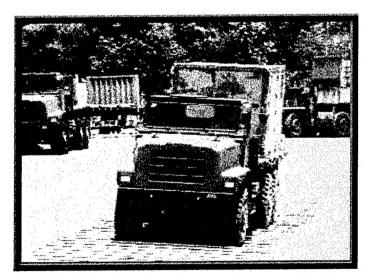
D. PANIC STOPS: No damage or failures occurred with the S-280 Shelter, S-280 Shelter Tie-down Kit or the vehicle.

Panic stop testing of S-280 Shelter with Tie-down Kit
